Real Estate

Continuing Professional Development

Physical property inspection

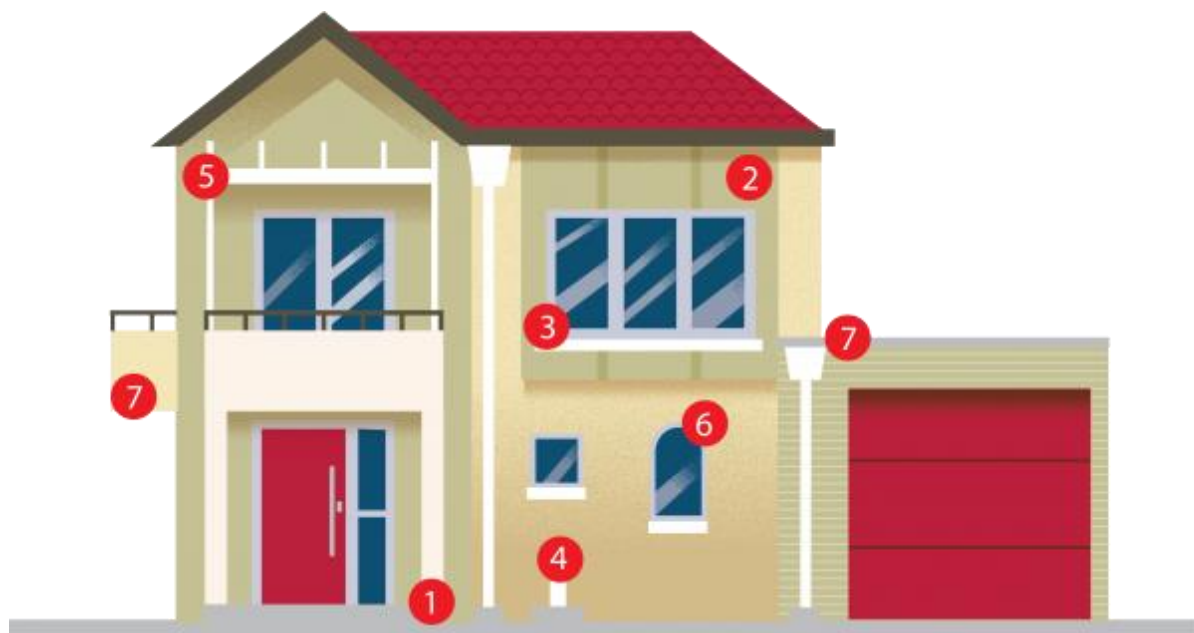
Modern home with potential leaky home risks

Leaky building risks

1. Ground clearance: Not enough space between the cladding and the ground, paving or deck or insufficient slope away from the edge of the building. The clearance to solid ground (concrete, asphalt, paving or decking timber) should be 150mm. The clearance to soil should be 225mm.

2. Cracking in cladding: Look for hairline cracks in the cladding, typically found close to windows and doors, or discoloured cladding in these areas.
3. Joinery: Check for cracks along the joinery seals between the joinery and the cladding.
